Research Note

Wood Performance in Doorways of Single-Family Houses

THOMAS W. POPHAM, RODNEY C. DeGROOT, AND RONALD W. HOWE

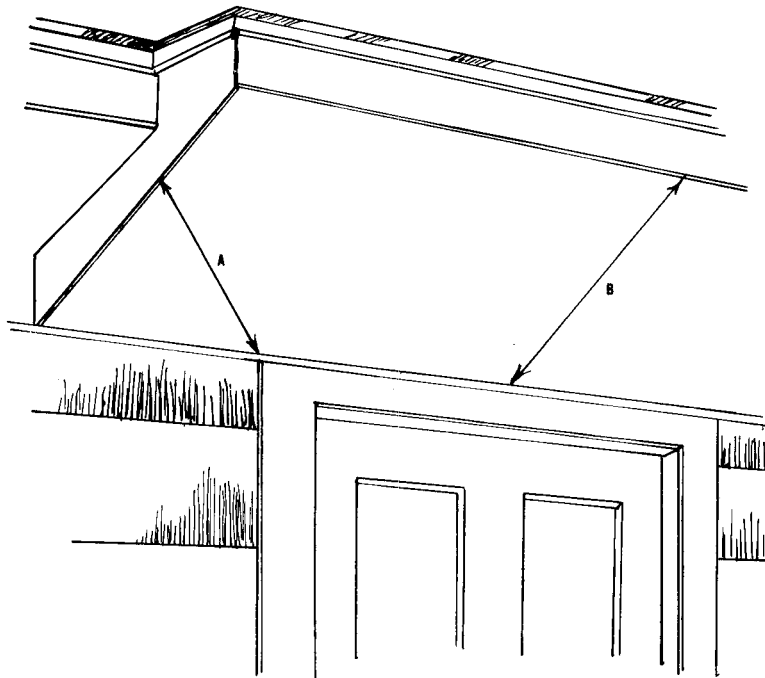
Figure 1.—Measurement of overhang at doorways: A, Overhang distance to nearest edge from doorway; B, Overhang distance to edge directly in front of the doorway. In some instances A and B are the same.

The average distance to the edge of the roof directly before the doorways was 57 inches. The average minimum distance to edge of roof overhang above the doorways was 49 inches. Regression analyses of the relationships between distance to edge of roof overhang and wood moisture content never explained more than 5 percent of the variation in observed wood moisture contents.

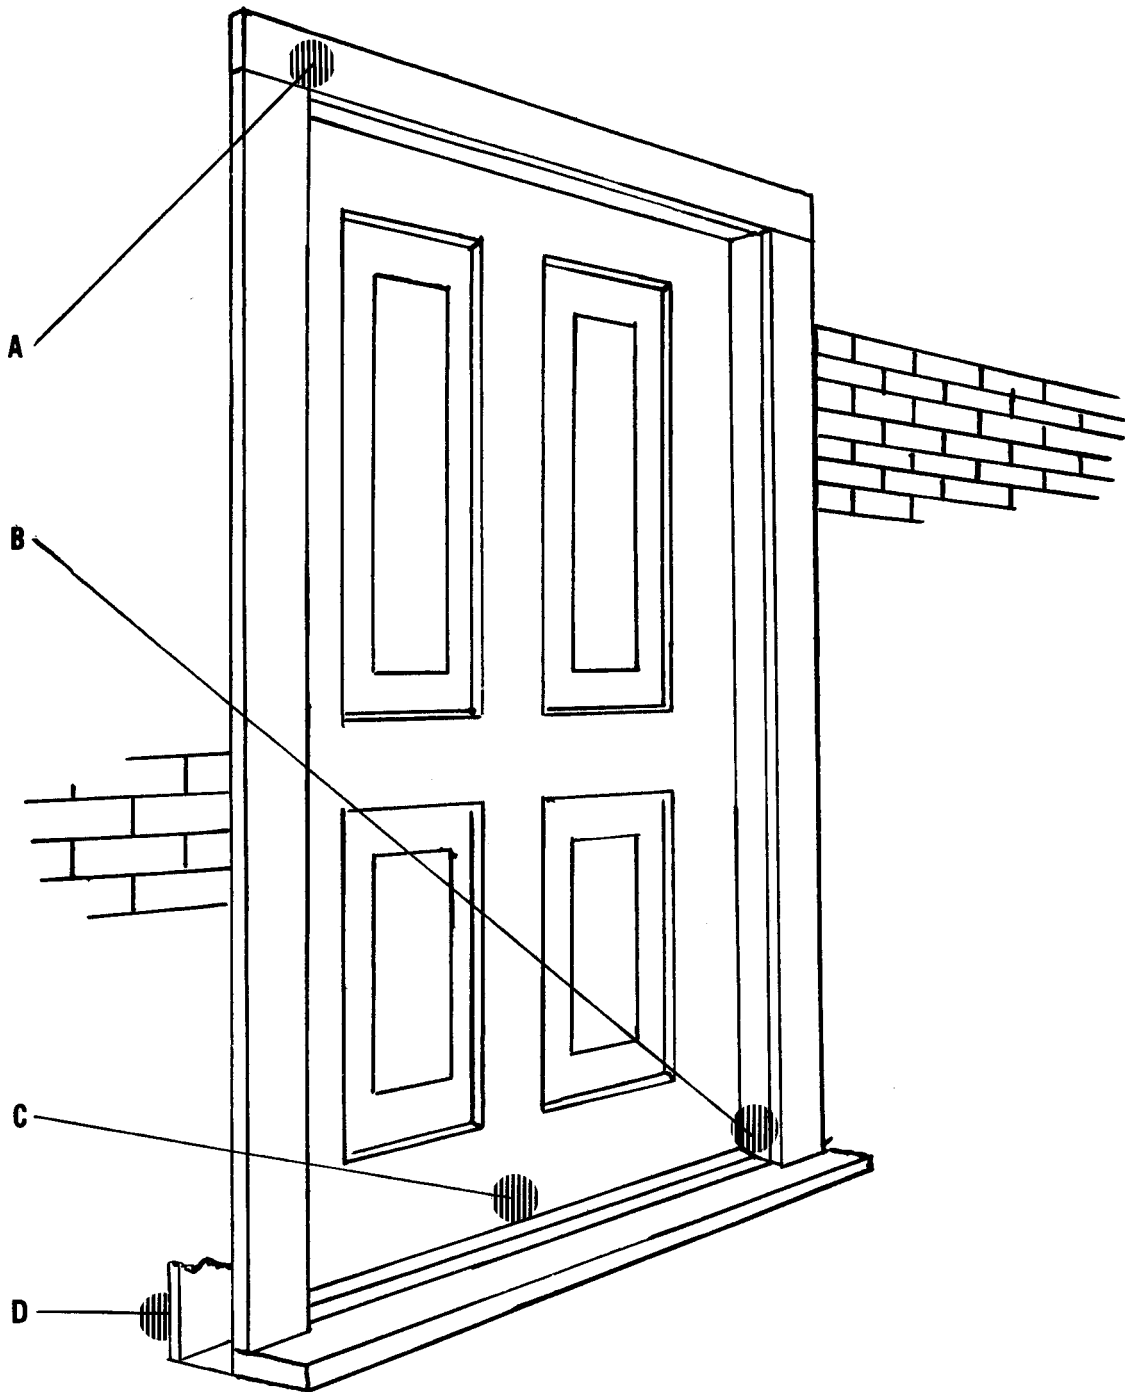
The average wood moisture content of the frames was 11 percent (Standard deviation = 1.84) at the top of the exterior casing, 13 percent (sd. = 6.04) at the

Figure 2.—Moisture content measurements in doorway area; A, Top of the exterior casing; B, Exterior base of the jamb; C, Exterior bottom of the door; D, Base of the interior casing.

exterior base of the jamb, and 15 percent (sd. = 7.58) at the base of the interior casing. The consistency of wood moisture contents at the top of the exterior casing is the result of the protection the roof overhang

affords to this part of the doorway. Moisture content at the top of the exterior casing was never above 30 percent, but in nine houses, either the exterior base of the jambs or the interior casing had moisture con-

tents above 30 percent (30 to 95 percent), a level beyond which decay occurs in untreated wood. In no case was a moisture content of above 30 percent caused by a specific rainfall. The fact that moisture content in the base of the frames varied considerably indicates that this area is often wet. Construction that retards drying has more influence on moisture content at the base than at the top of frames.
